**Constraints & Feasibility Study,
Arboricultural Implications Assessment,
Tree Protection Plan
65-67 Stamford Hill
London N16 5TJ**

Date of Survey: 12 December 2012

Reference: 2108-TSE

Date of report: 19 December 2012

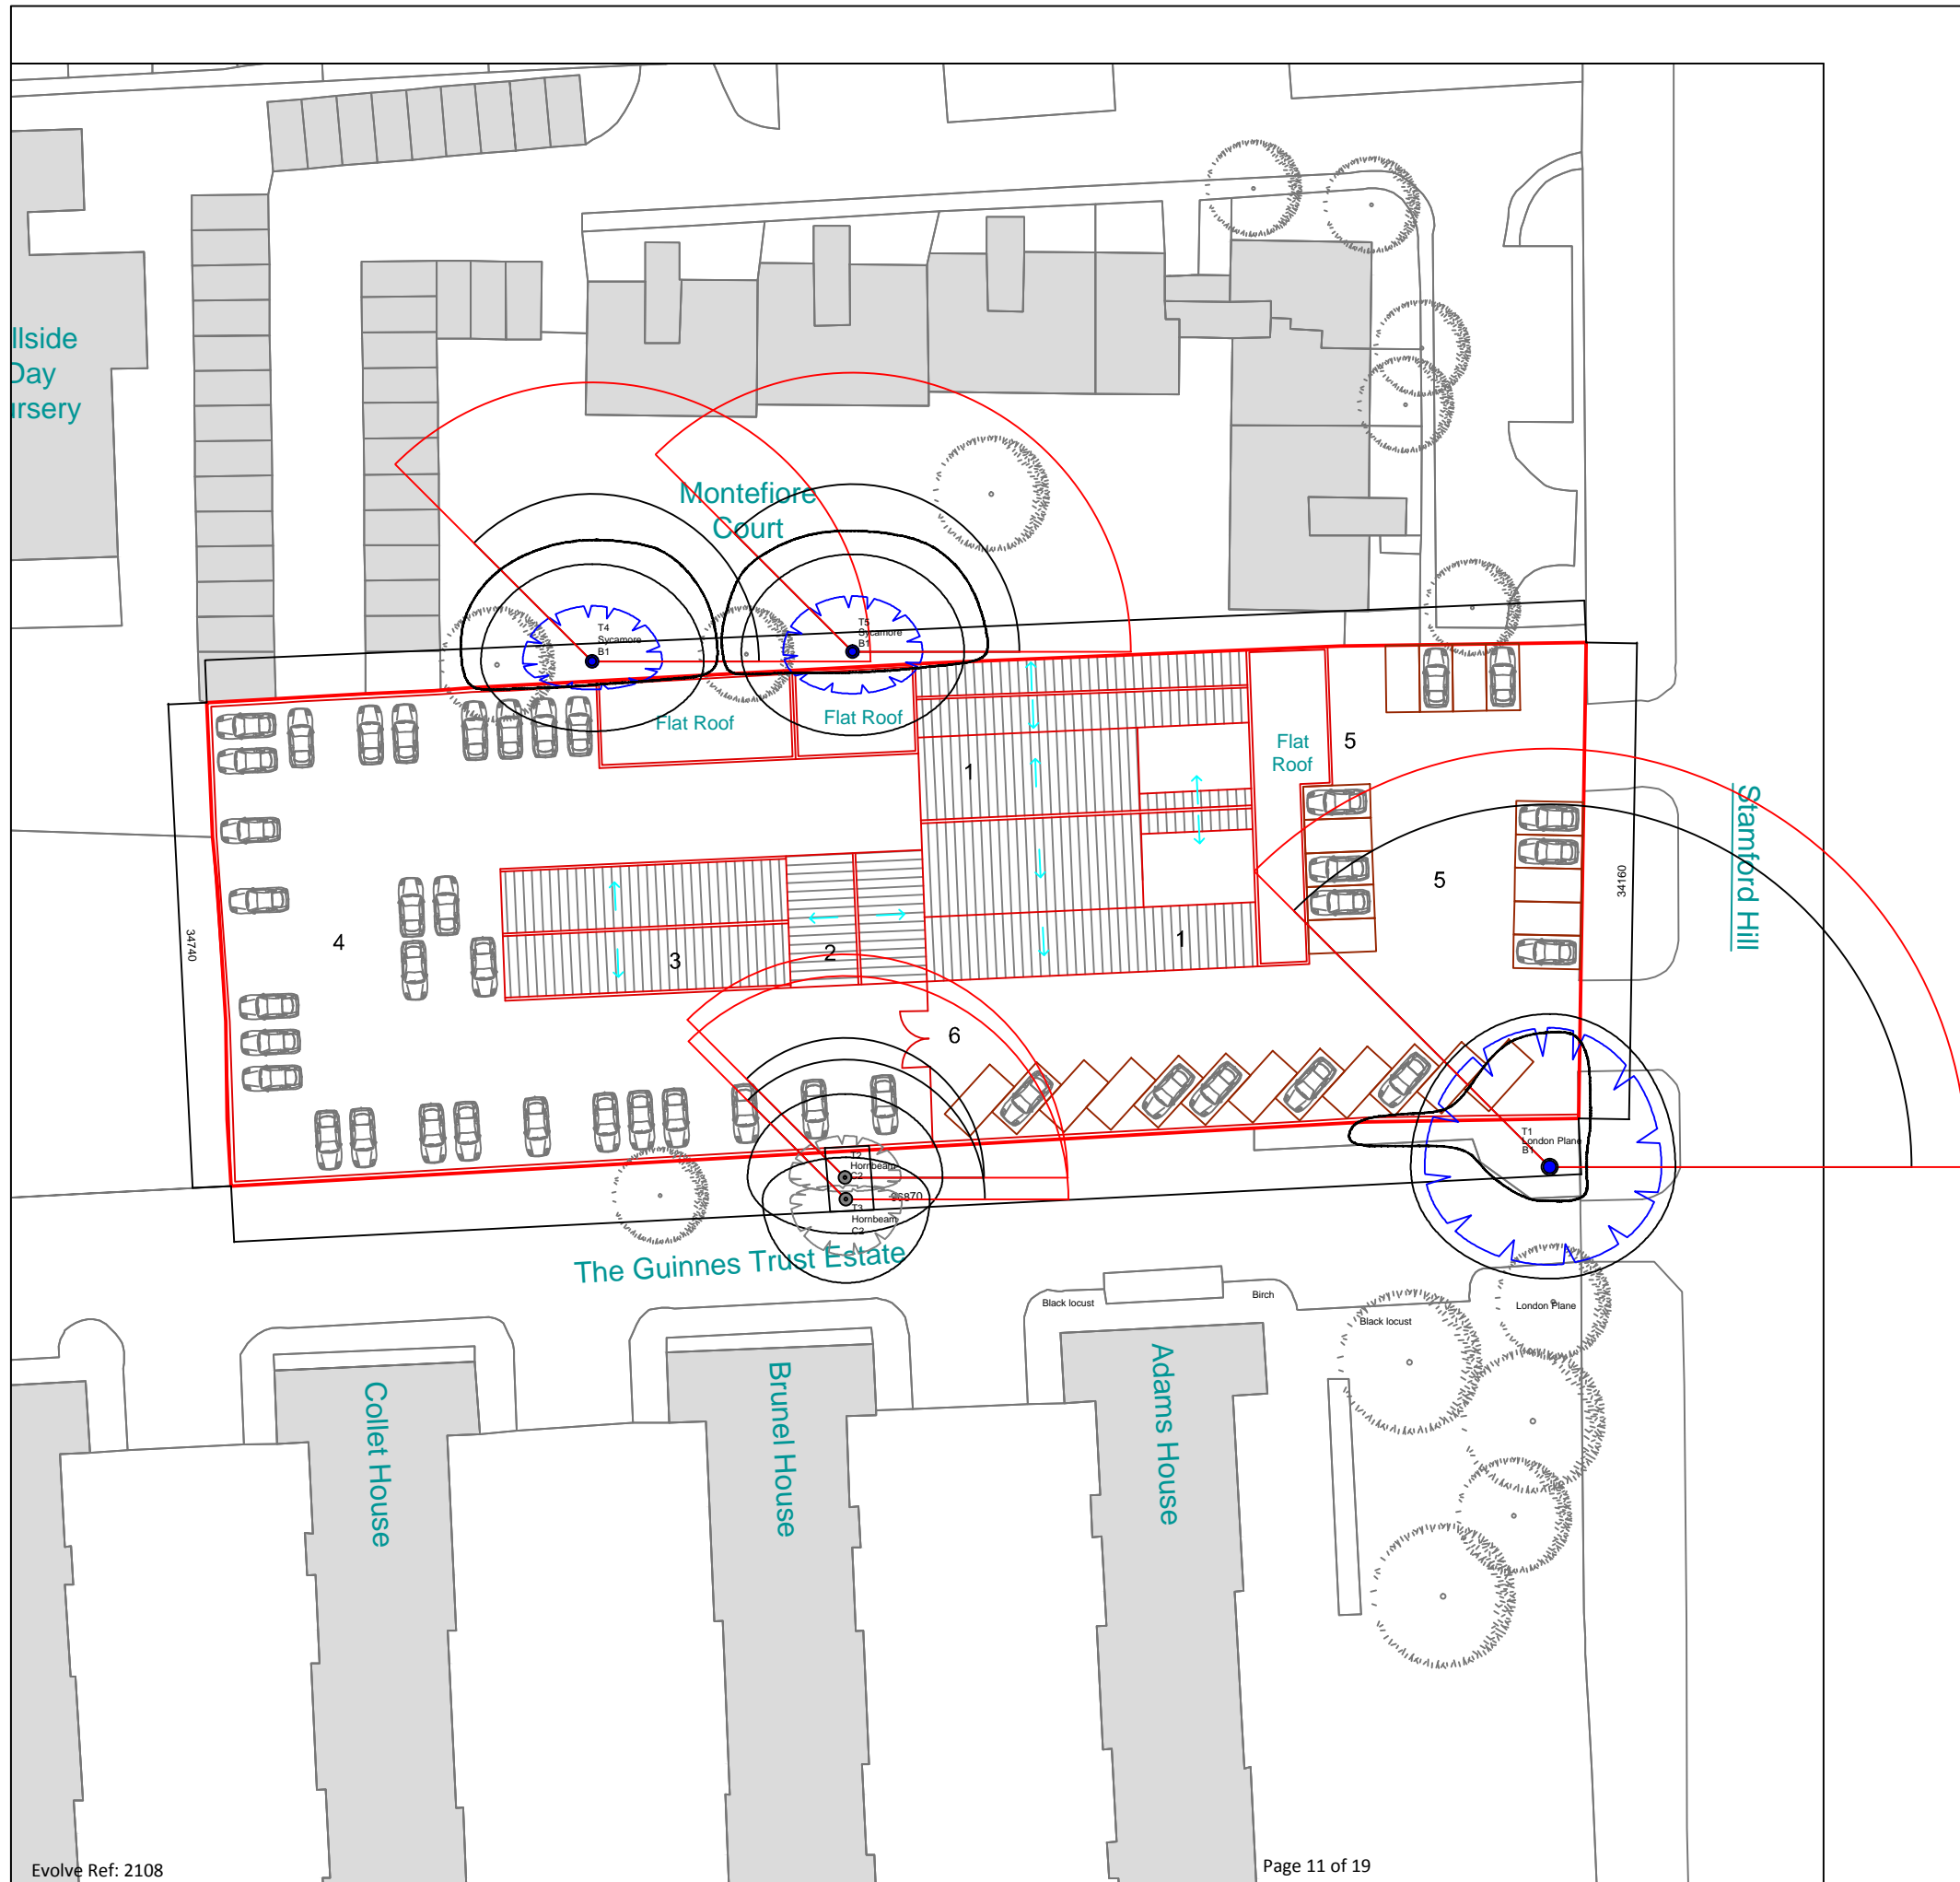
APPENDIX A - Tree Constraints Plan

- 6.1.1 The important issue in this case is that any damage to the trees in neighbouring ownership may be subject to legal sanction.
- 6.2 The constraints presented by the trees are limited to the identified root protection area of the London Plan T1 and the sycamores T4 and T5.

- 6.3 I have amended the shape of the root protection areas (RPAs) from the circles as initially presented to reflect the presence of the roads and buildings. Tree roots will not extend far into these areas as the soil conditions are not suitable for growth due to compaction.

- 7.1 The trees affected are the London Plan T1 and the sycamores T4 and T5. Of these the most important issue is the location of the plan tree T1 adjacent to the remodelled entrance. This tree will be exploiting some of the area within the site proposed for the new entrance. This area is already under hard surfacing and the rooting here will be restricted but the removal and installation will have to be undertaken with care to ensure the damage is minimal. This can be readily achieved and I have included indicative methods for this type of operation. Soils will have to be analysed first to allow a site specific specification.

- 7.4 The existing walls will be used as tree protection barriers unless they are to be replaced when marine grade ply will be used to protect the trunks of the trees.

- 7.5 The removal of existing structures and hard surfacing can be undertaken with no reference to trees for most of the site. Where the hard surfacing will be removed and replaced next to T1 the method statement at Appendix F will be followed. The installation of new hard surfacing will be designed so as not to require any digging into the existing mineral soils.
