**Constraints & Feasibility Study,  
Arboricultural Implications Assessment,  
Tree Protection Plan  
65-67 Stamford Hill  
London N16 5TJ**

**Reference:** 2108-TSE

**Instructions:** We have been instructed by Drawing & Planning on behalf of Agudas Israel Housing Association to undertake a survey of the trees and provide the following:

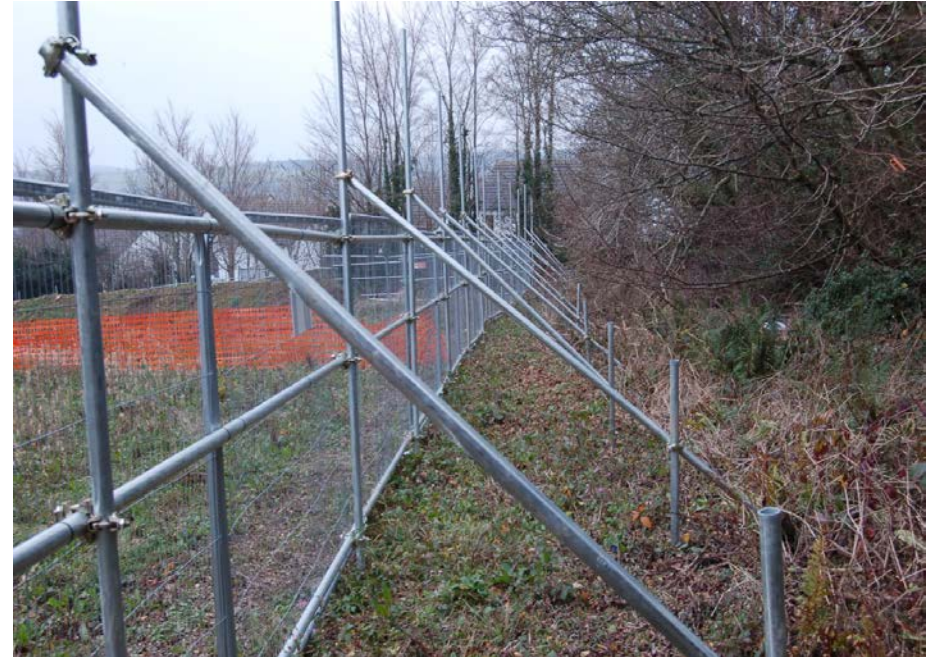
The combined RPAs forming the Construction Exclusion Zone are to be protected by Tree Protection Barriers as per the recommendations in BS 5837:2012 (Figure 2). The photographs show correctly installed fencing.

The fencing will comprise (a minimum height of) 1.8 metre high welded wire mesh panels (or exterior grade plywood with a minimum thickness of 20 mm) supported on a braced scaffold framework with the uprights driven securely into the ground.

**Tree Protection:** The Construction Exclusion Zones shall be marked out by an Arboricultural Consultant and enforced by the erection of protective fencing. This protective fencing will be in compliance with the specification recommended in the British Standard 5837:2005 Figure 2 attached.
